31 March 2021

**Subject: Environmental Monitoring Report – 2020 Annual Operation & Maintenance Report – MIG/DeWane Landfill Site, Belvidere, Illinois**

# 1<sup>ST</sup> QUARTER 2020 INSPECTION REPORT

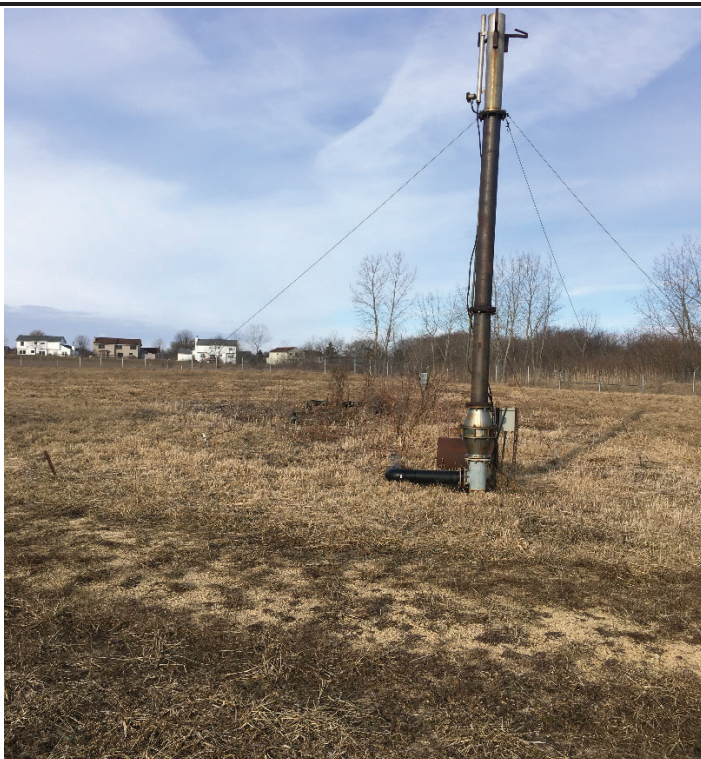
**Photograph 1**

**Comments: Blower**

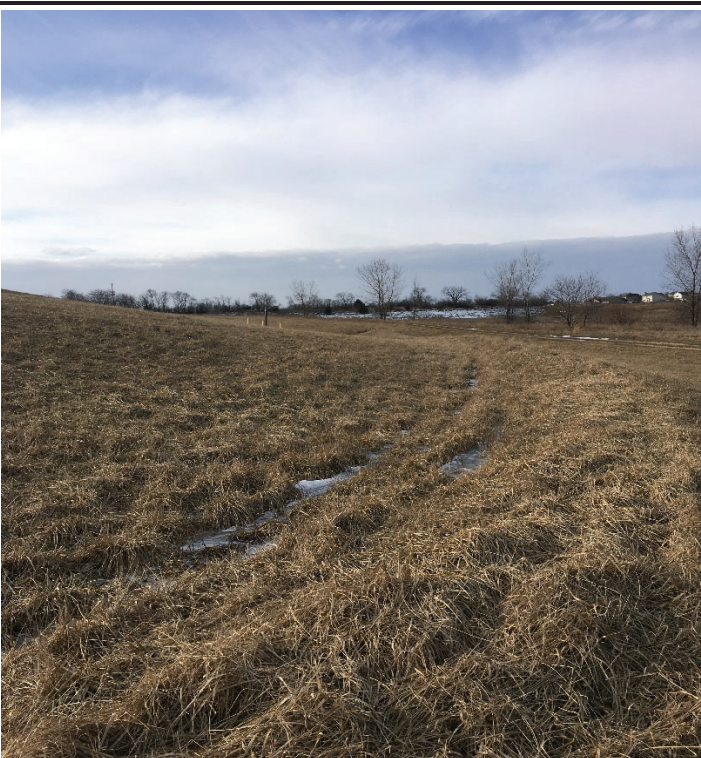
**Photograph 2**

**Comments: Lower  
drainage berm**

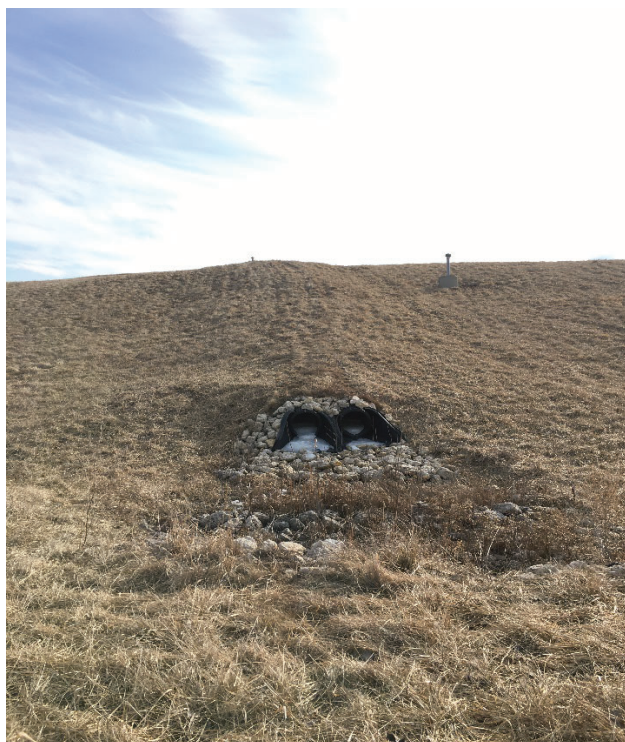
**Photograph 3**

**Comments: Down chute**

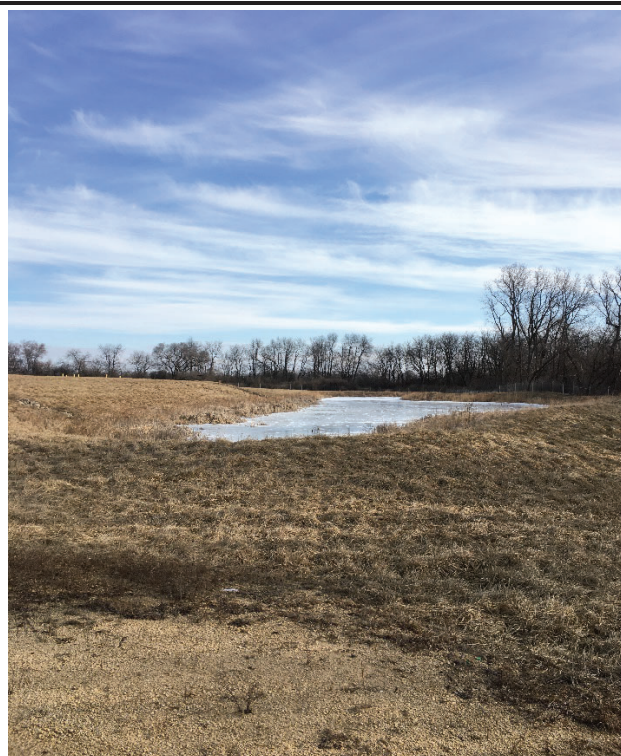
**Photograph 4**

**Comments: Southeast storm water pond**

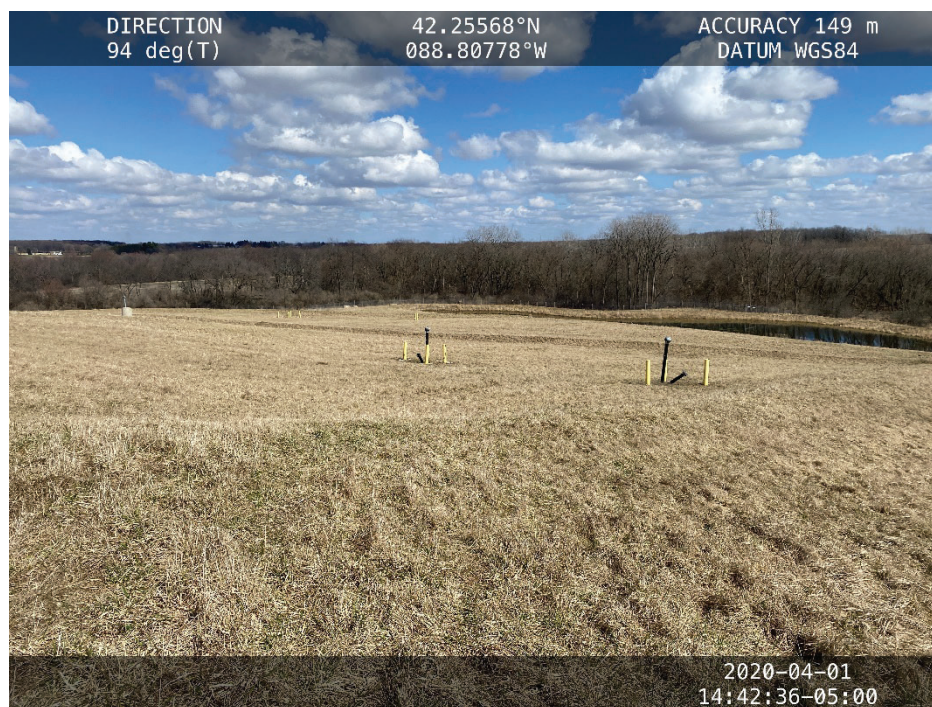
### Photograph 5

**Comments: Side slope  
and north east storm  
water pond**

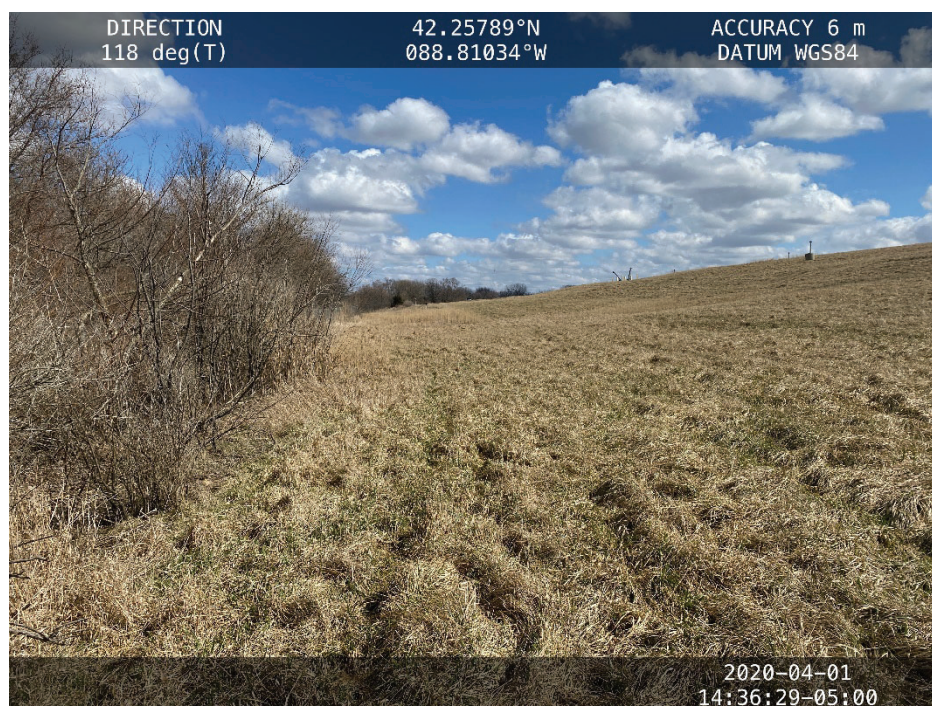
### Photograph 6

**Comments: Northern  
side slope**

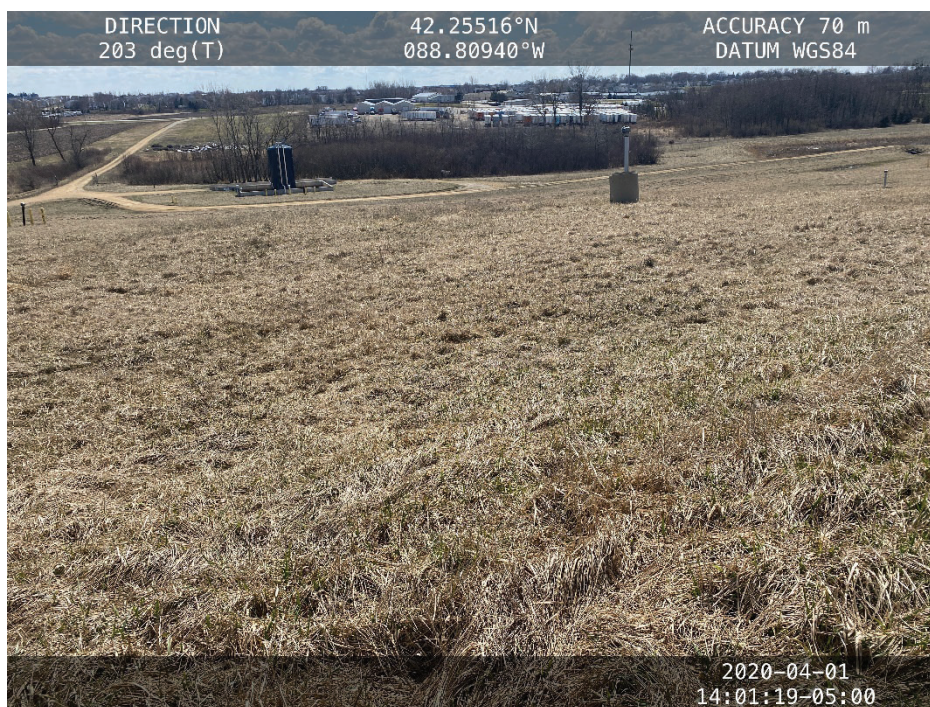
**Photograph 7**

**Comments: Southern  
side slope**

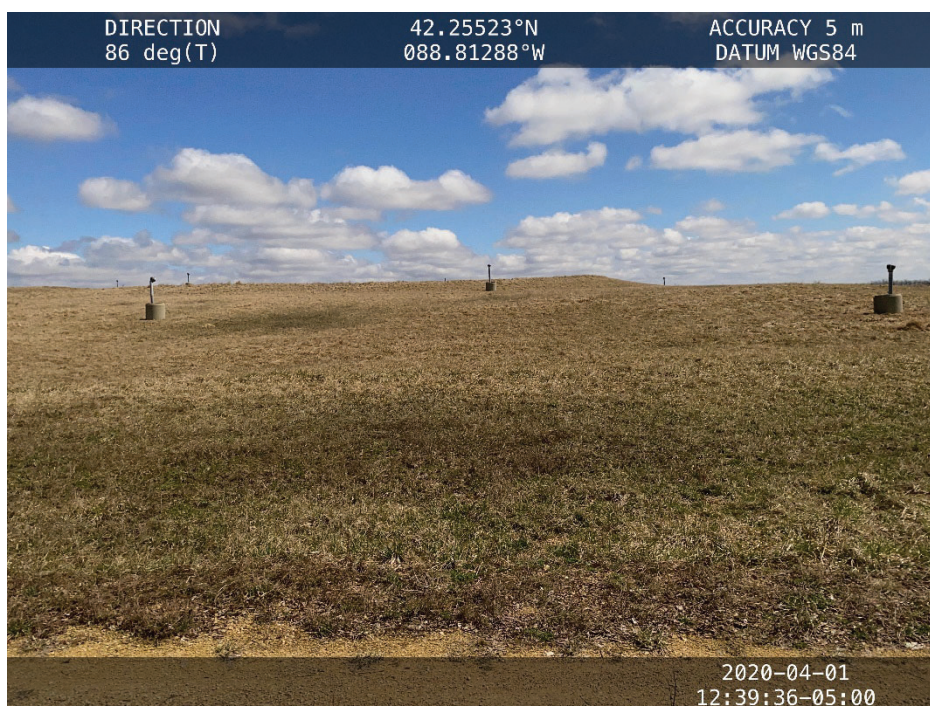
**Photograph 8**

**Comments: Western  
side slope**

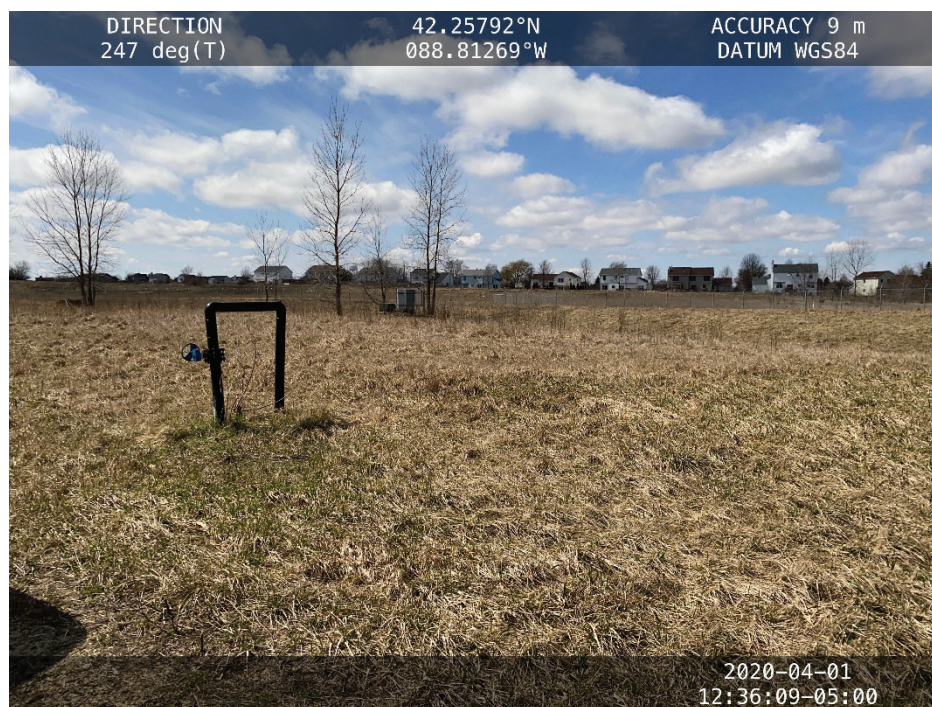
**Photograph 9**

**Comments: Riser  
column and borrow pit**

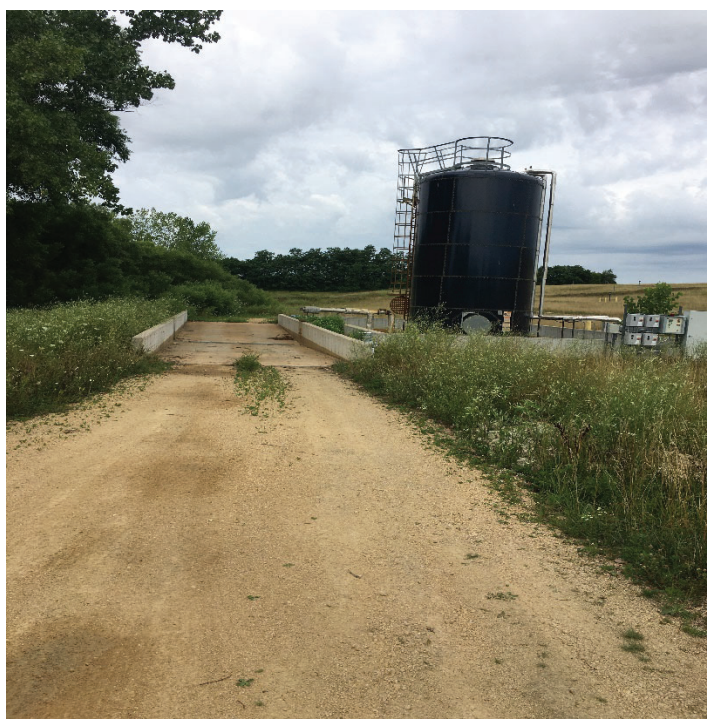
**Photograph 10**

**Comments: Above  
ground storage tank**

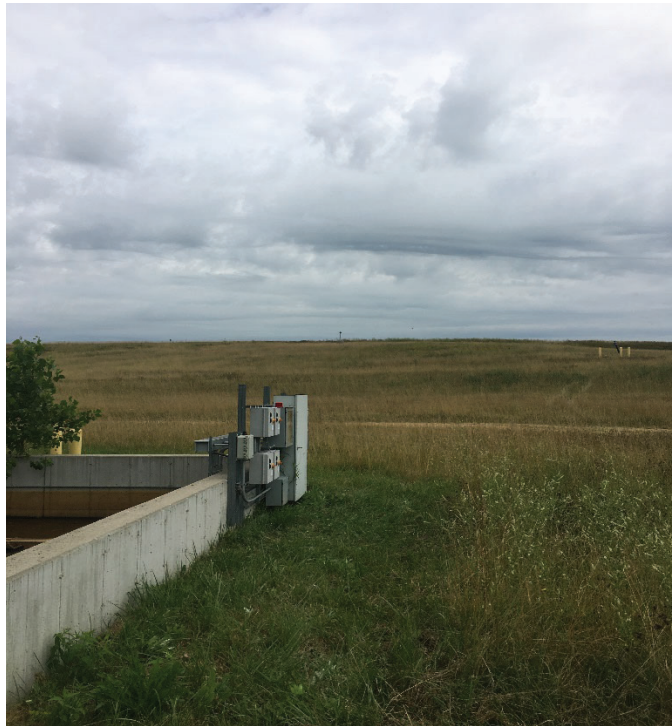
**Comments: Above ground storage tank panels**

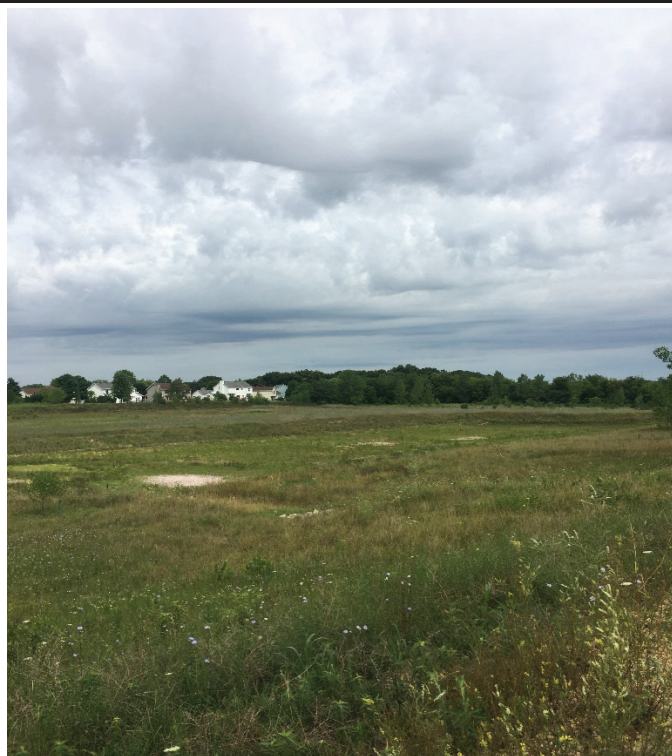
**Photograph 12**

**Comments: Borrow pit**

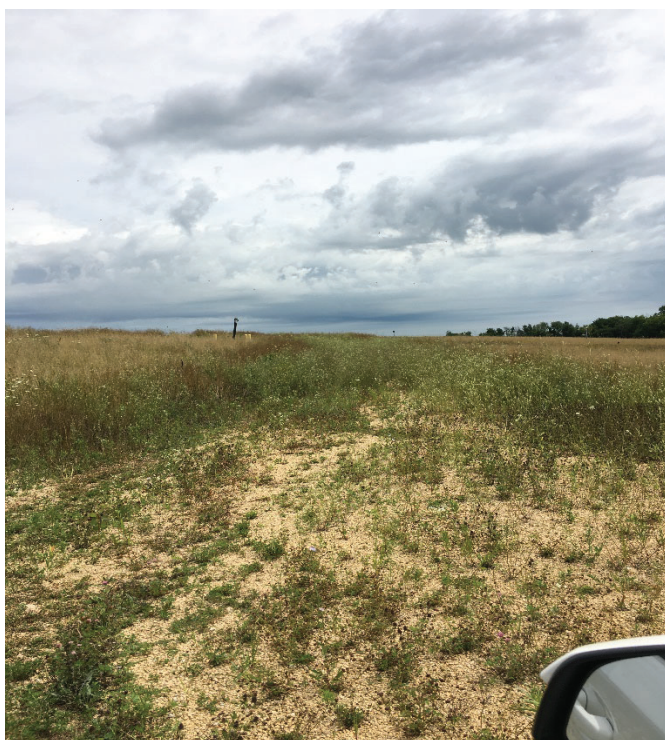
**Comments: Overgrowth  
on access road**

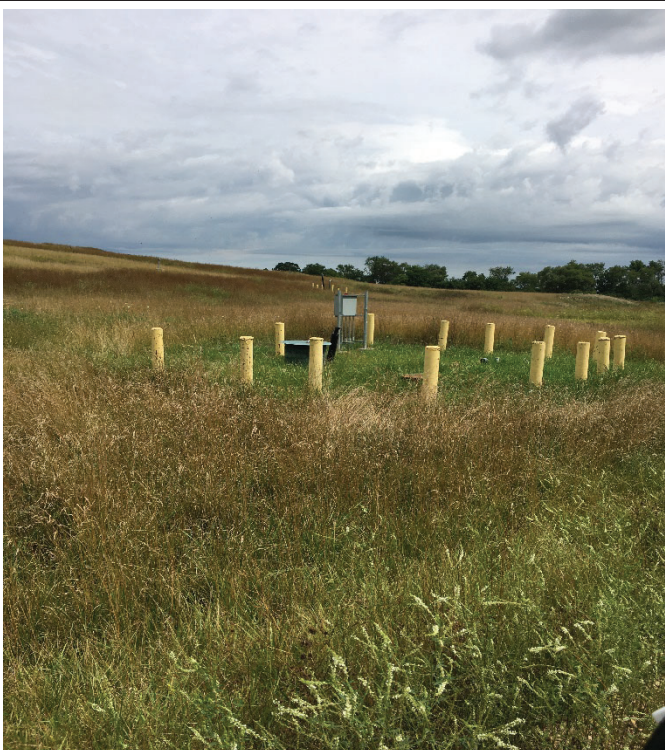
**Photograph 14**

**Comments: Southeast  
storage tank**

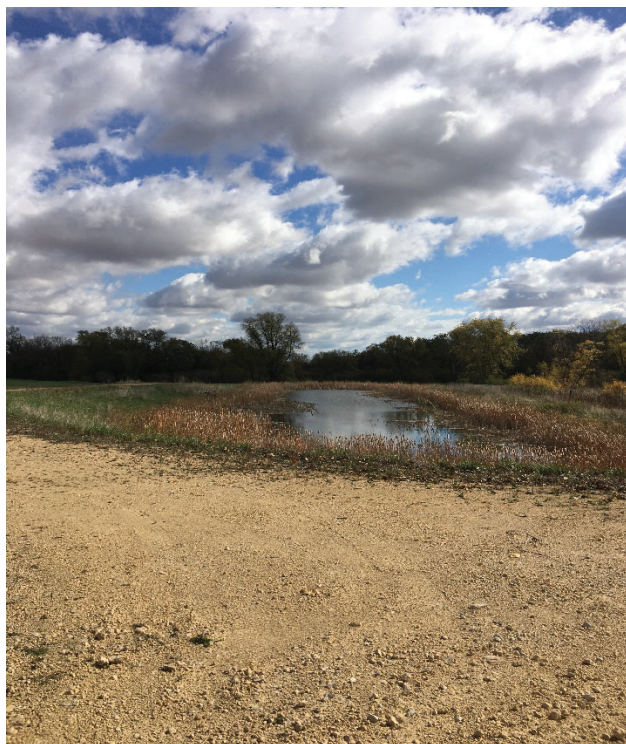
**Comments: Southeast storm water pond**

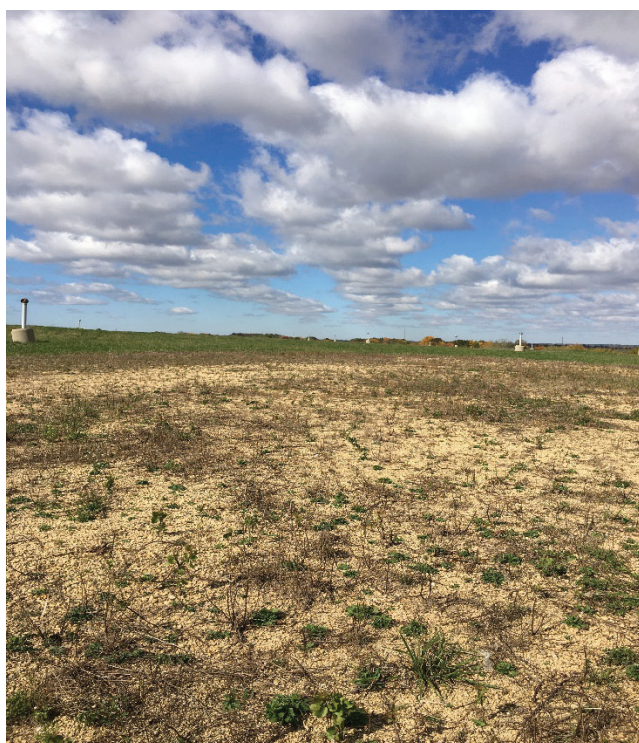
**Photograph 16**

**Comments: Plateau**

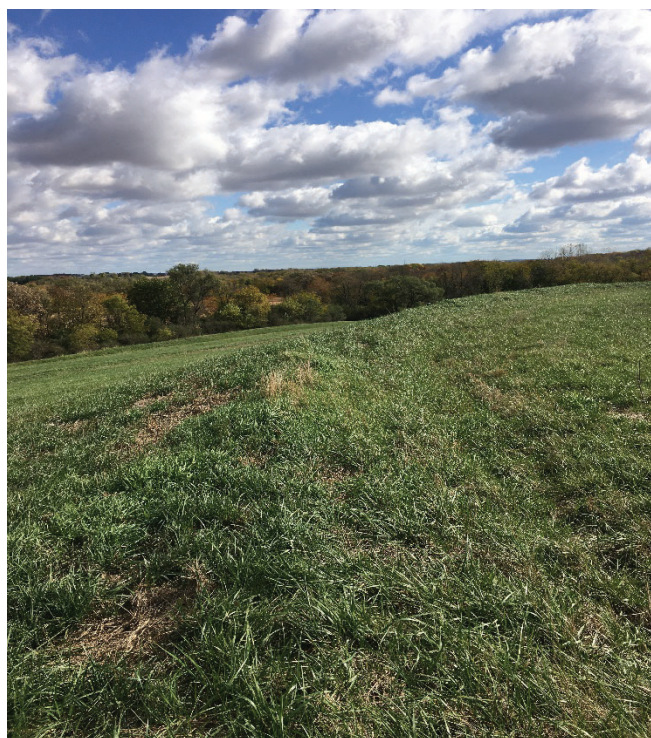
**Comments: Upper storm water berm**

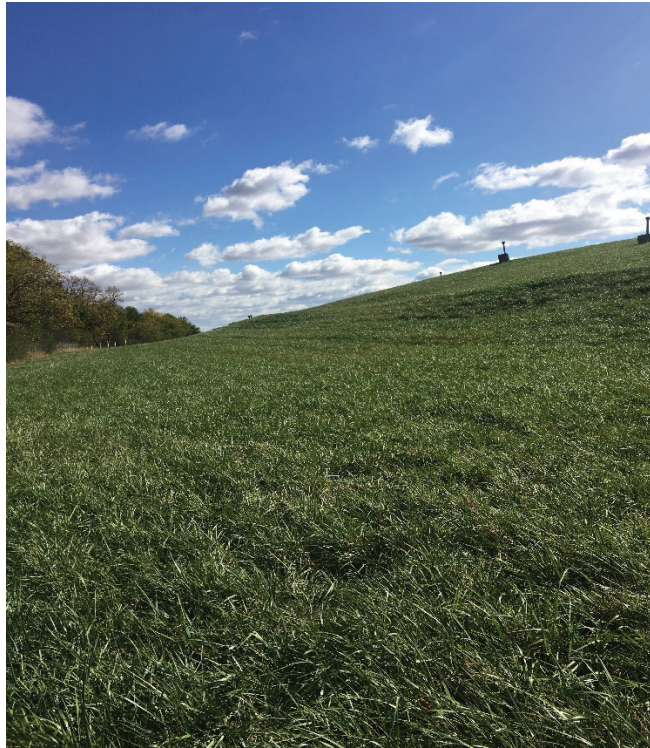
**Comments: Northern  
side slope**
